Manhole Inspection Summary

Manhole # S61CC_002MH

Insp Date: **3/17/10 3:08 PM**

Location Address: **Pulaski**

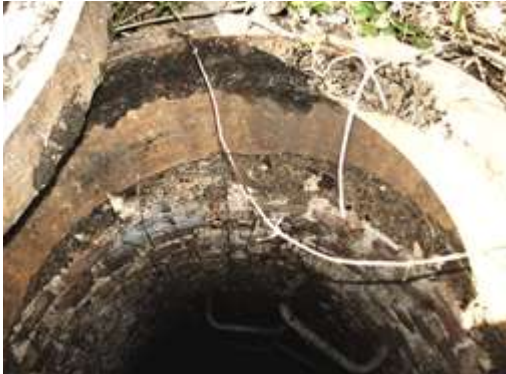
Defect 3

Frame Offset: **2** (in.)

☒ **Leaks**

offset

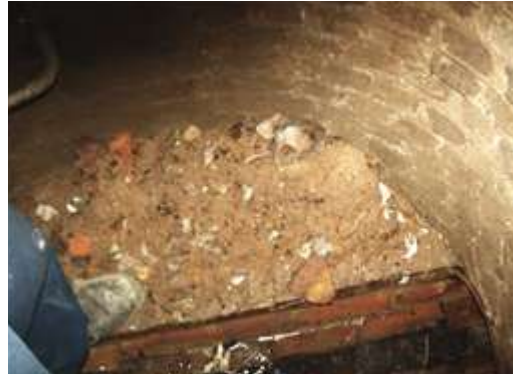
Defect 2

Condition: ☐ Sound ☐ Cracked ☐ Root Intrusion ☐ Deteriorated ☐ Leaks ☒ **Debris**

debris

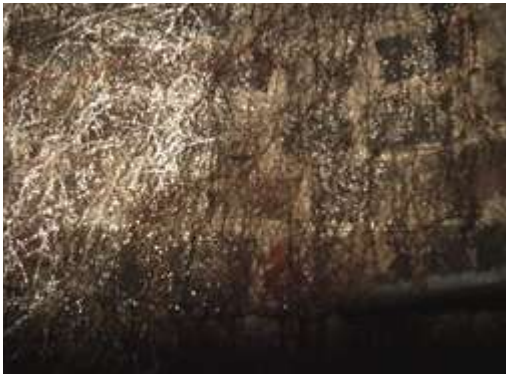
Defect 1

Infiltration: ☐ None ☐ Joint ☐ Cracks ☐ Mortar ☒ **Roots** ☐ Wall

infiltration

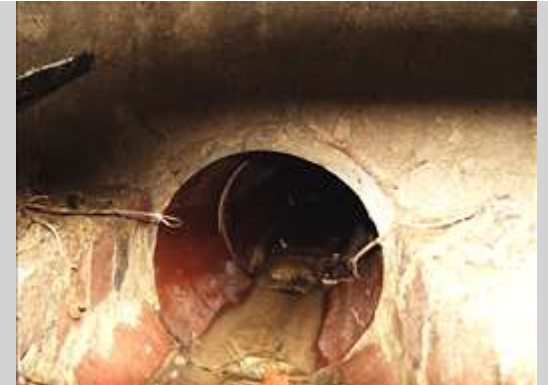
12 O'Clock Outflow

10 in. Circular Gravity Sewer
Pipe Out @ 12 O'Clock

Pipe Height: **14.4** (in.) Rod and Bar (Angled)
Pipe Material: **Clay** ☐ Pipe Lined
Invert Depth: **12.67** (ft.) Flow Characteristics: **Slow**
Deposits: ☒ None ☐ Mud ☐ Sludge ☐ Debris ☐ Grease
Silt Depth: (in.) Deposits Extent:
Infiltration: **None** Pipe Seal Cond: **Sound**

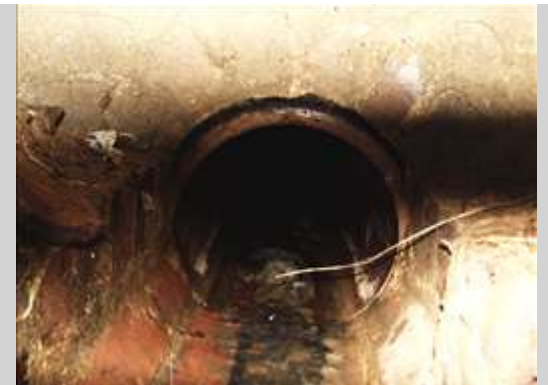
6 O'Clock Inflow

10 in. Circular Gravity Sewer
Pipe In @ 6 O'Clock

Pipe Height: **14.4** (in.) Rod and Bar (Angled)
Pipe Material: **Clay** ☐ Pipe Lined
Invert Depth: **12.58** (ft.) Flow Characteristics: **Slow**
Deposits: ☒ None ☐ Mud ☐ Sludge ☐ Debris ☐ Grease
Silt Depth: (in.) Deposits Extent:
Infiltration: **None** Pipe Seal Cond: **Sound**
